DEPARTMENT OF TRANSPORTATION

Contract #: 04-0120F4Cty: SF/ALA Rte: 80 PM: 13.2/13.9File #: 69.28**WELDING INSPECTION REPORT****Resident Engineer:**Siegenthaler, Peter**Address:** 333 Burma Road**City:** Oakland, CA 94607**Report No:** WIR-017641**Date Inspected:** 01-Oct-2010**Project Name:** SAS Superstructure**OSM Arrival Time:** 700**Prime Contractor:** American Bridge/Fluor Enterprises, a JV**OSM Departure Time:** 1900**Contractor:** Zhenhua Port Machinery Company, Ltd (ZPMC), Changxing Island **Location:** Shanghai, China

Bridge No: 34-0006**Component:** OBG/TOWER**Summary of Items Observed:**

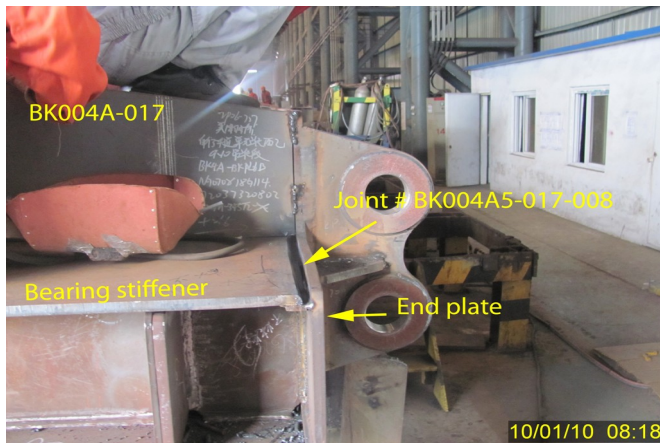
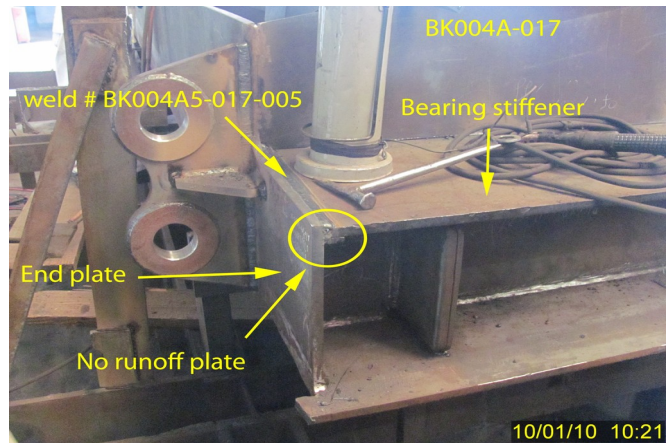
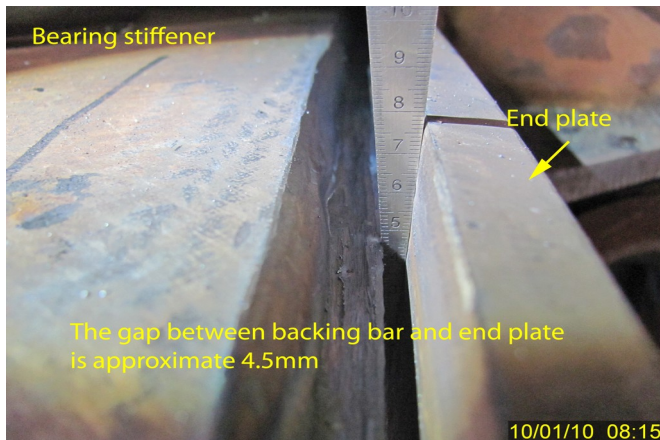
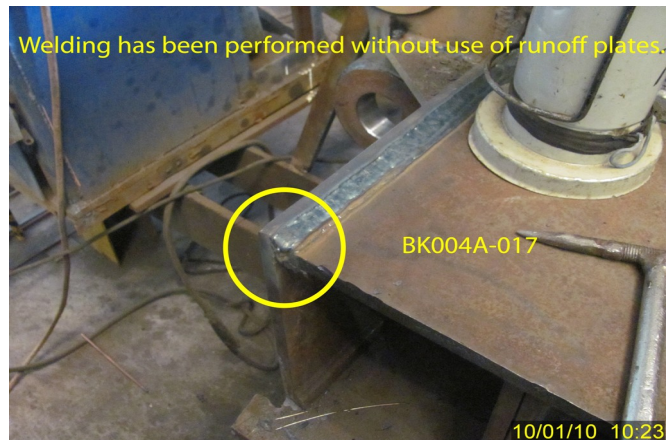
- The welding has been performed without use of runoff plates.
- The welds are Complete Joint Penetration (CJP) with steel backing joining the Bearing Plate (BKPL7A/B) and end plate (BKPL3A/B).
- The welds are identified as: BK004A5-017-005 and BK004A3-017-002.
- The member is located in bay 11.

- Steel backing was not properly placed and held in intimate contact with the base metal.
- The gap between steel backing and side plate is observed approximately 4.5mm.
- The weld is Complete Joint Penetration (CJP) with steel backing joining the Bearing Plate (BKPL7B) and End Plate (BKPL3B) of bike path.

- The weld is identified as: BK004A5-017-008.
- The member is located in bay 11.

This issue has an incident report. The attached photographs provide additional detail.
